Test of time

Impala 28

Geoff Hales revisits a 15-year-old design which can still race competitively under CHS, IOR and IMS, cruises well and even appreciates in value

SURVEYOR'S REPORT

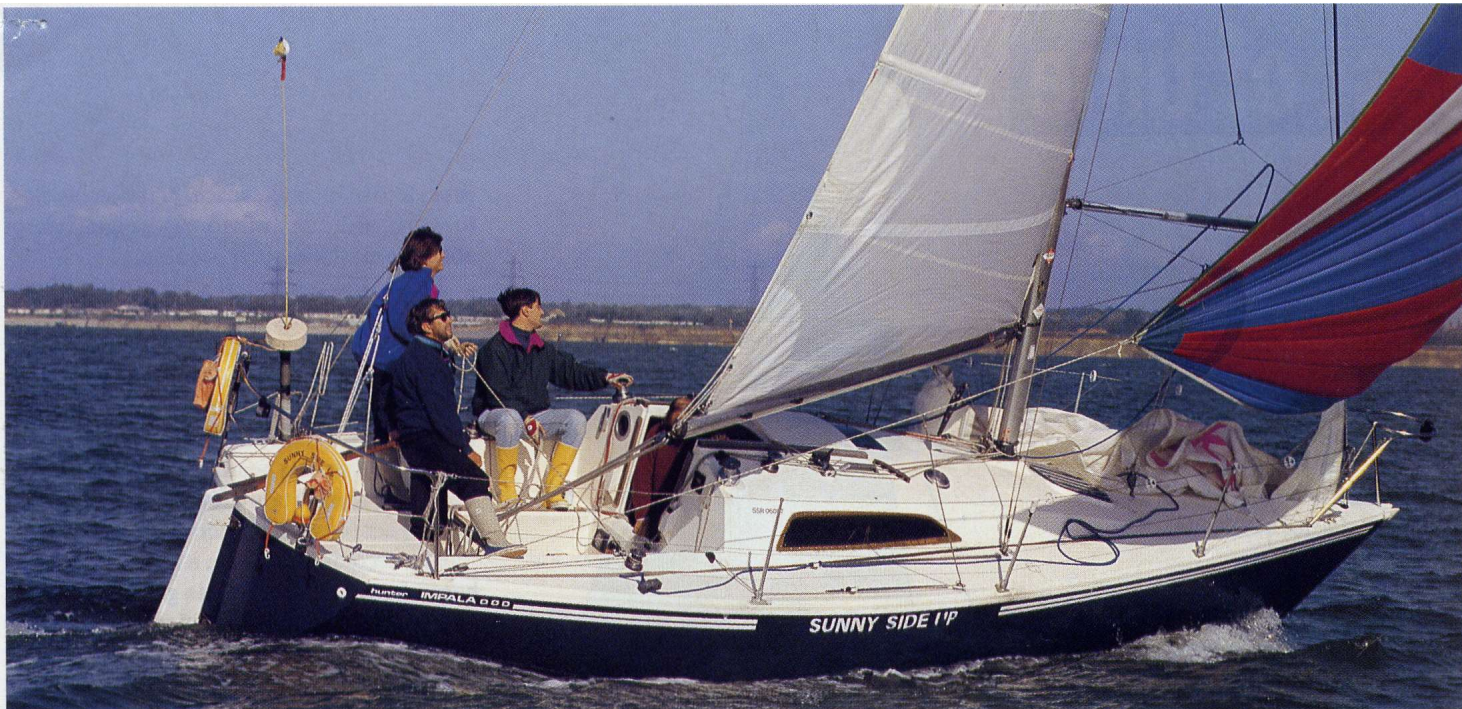
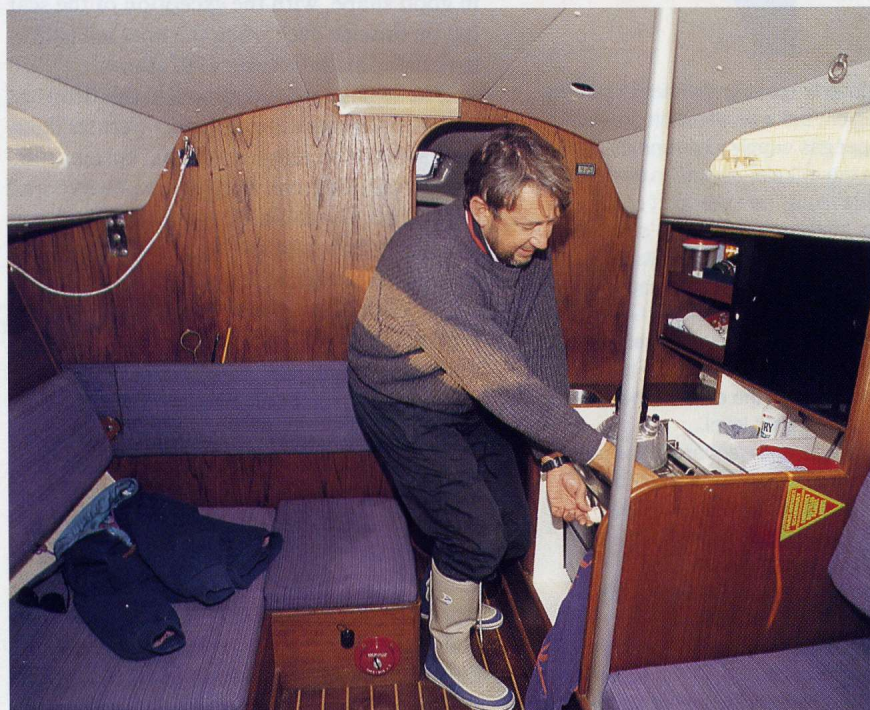
Top, under spinnaker, *Sunny Side Up* was like a big dinghy. **Above and below right**, the galley and chart table are mounted on the main bulkhead forward, allowing space for

two settee berths and pilot berths aft. **Below left**, a clean transom and transom-hung rudder conceal *Sunny Side Up's* well for the outboard motor

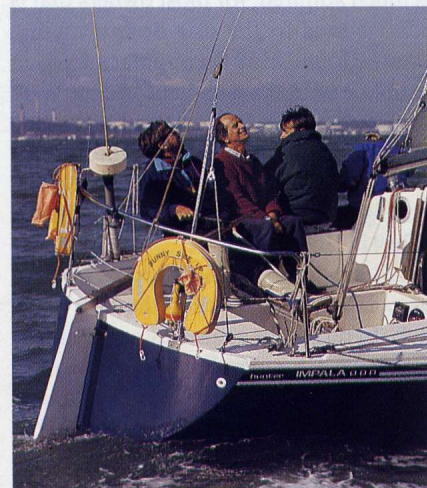
Locker lids are foam-cored for stiffening, but have been known to delaminate

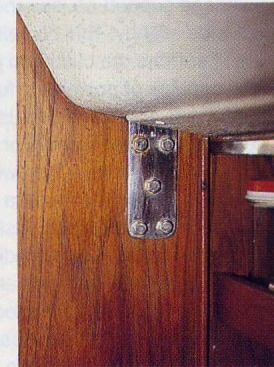
Chainplates for the lowers and cap shroud are small. The clevis pin can draw out or shear its locking pin

The combined lower and cap shroud chainplates are approximately 0.10in thick. This is a lot less than the width of the rigging screw fork end and, as a result, the clevis pins can tend to draw out and possibly shear their locking pins or rings and can suffer local wear.

A collar plate round the cap and lower shroud chainplates provides a watertight seal through the deck. But under load the seal can be broken as the collar moves up with the chainplate. The sealant works better if the chainplates pass easily through the collars.
